Health Care Facility: **Maintaining Operational Continuity**

In early 2013, ACR was dispatched to inspect a fire/smoke damage loss (compounded by water damage due to firefighting efforts) at a health care facility in Cook County, IL. The facility is a Medicare/Medicaid residential community and had suffered a fire associated with its laundry room as a result of work being done on the roof. There was certainly significant damage as a result of the fire and smoke, but during the process of fire damage inspection, the damage revealed a significant mold problem that otherwise had not been brought to light.

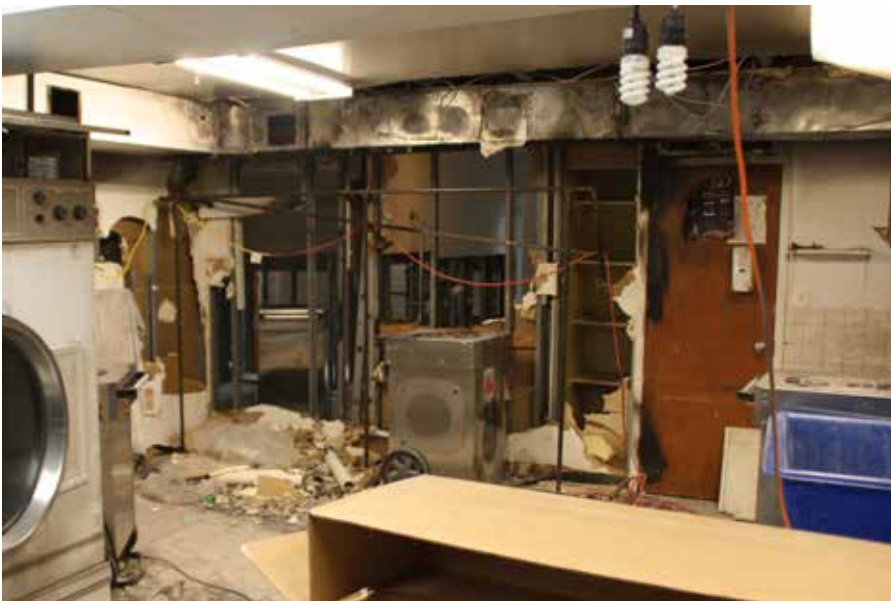
The site sustained serious fire and smoke damage and was in a state of disaster, with structural materials charred, sooty or displaced entirely. The disengagement of the materials is what revealed the presence of mold, as well as an obvious repeated contact with water in the past.

The fire started on the roof and appeared to have infiltrated the laundry room via a duct opening.

Initial response called for air scrubbers and temporary power and lighting. The correct procedure for fire clean up is methodical and planned recovery moved forward.

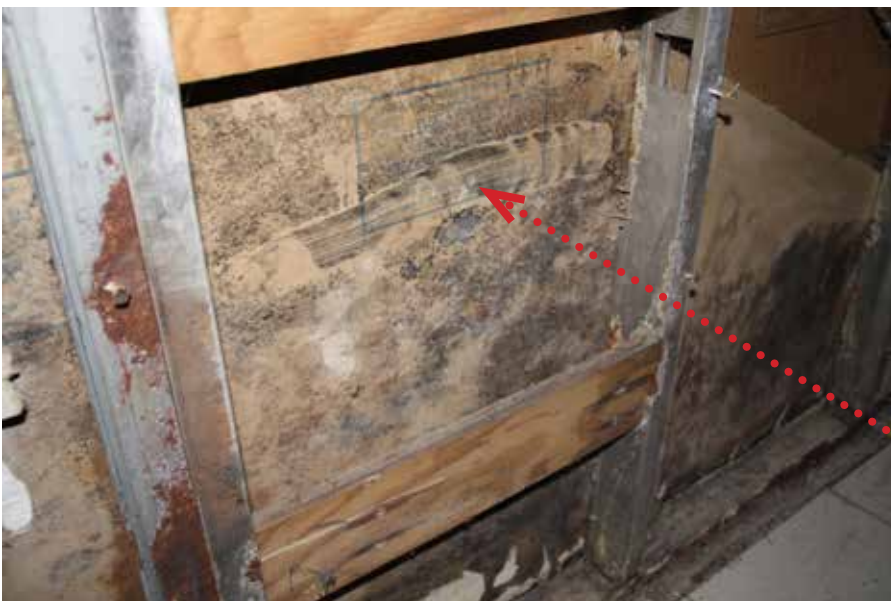
Very quickly, the mold was revealed to be substantial throughout the area originally identified as suspect. It is common to see vast colonies of mold growth behind dry-wall that frontally appears minimal or mold free.

We also noticed the metal studs have localized rust in patterns associated with repeated past water exposure.

Patterns of mold growth often follow the path of organic compounds left on the surface when installed.

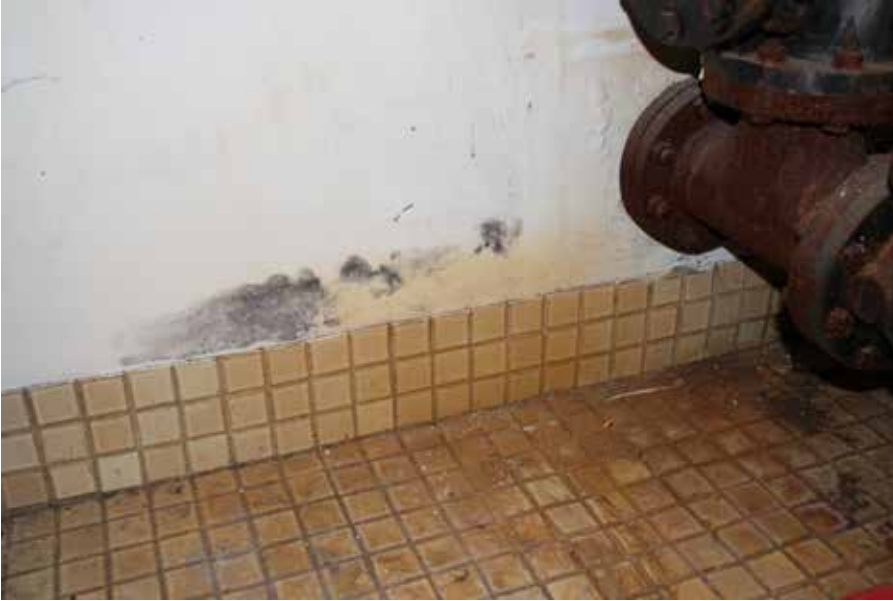
In some areas, potential mold growth was visible, although not suggesting any major or non-localized colonization. Even though this seems very obvious, we still defer to independent third party testing to confirm.

In areas near plumbing, mold growth such as this patch is often overlooked as "normal" and can be allowed months and years to accumulate behind the wall where conditions are favorable...temperature, moisture and the lack of light.

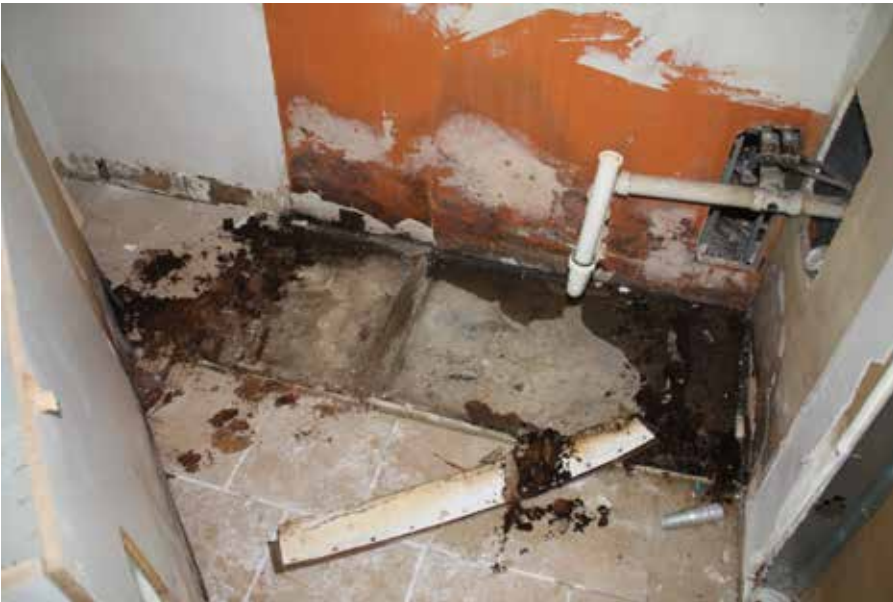
In this area where a sink was removed, it is definitely in need of cleaning. However, when the material was inspected closely, it became clear that mold had taken hold here.

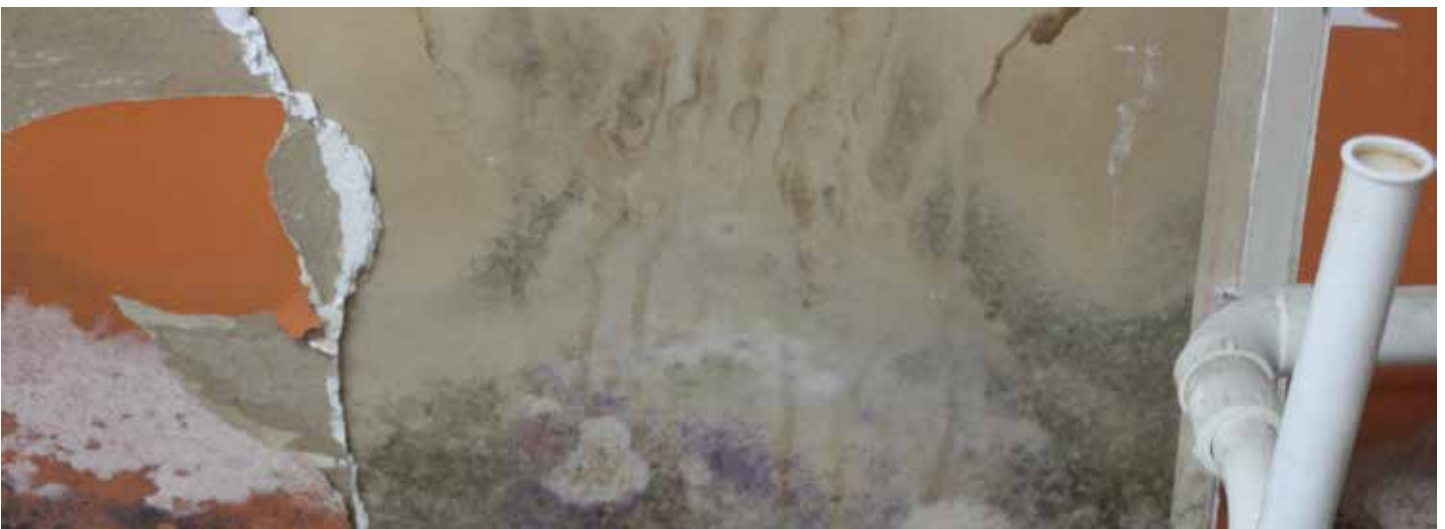
The removed wall material, below, shows that mold is deeply embedded and is consuming the available organic compounds.

Proper procedure indicates the cutting of wall material a minimum of two feet above the common height of the mold growth, then the complete removal of the board below.

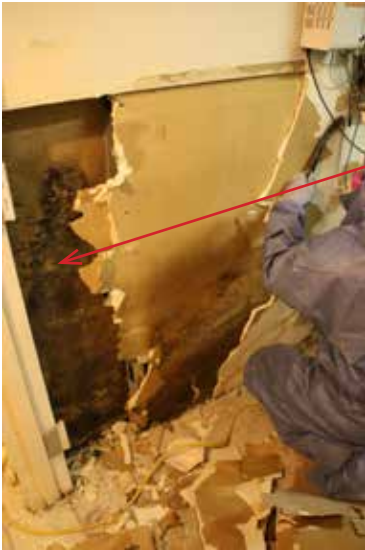
In this image, the wall's removal shows a profuse mold presence behind the wall of the neighboring room.

It takes significant experience and knowledge of building science to properly remove the wall materials that cover important infrastructure such as electrical, plumbing and more. And to execute this in full protective gear is not for the faint of heart.
