Fire and Smoke Damage in Unique Church

ACR has been called upon for more than 27 years to apply restorative cleaning after fire and smoke have damaged churches and their associated facilities. In mid-2012, ACR was dispatched to an extremely ornate church in Lake County, IL that had experienced fire damage as well as decades of accumulated smoke damage from candle burning.

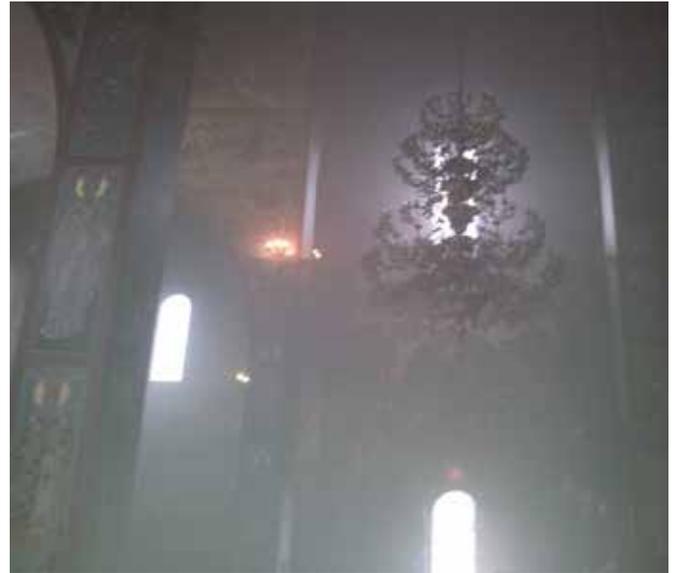
In the photo provided by the Church from immediately after the fire event, thick smoke is evident and copious.

Remaining evidence of the damage can easily be seen in photos capturing the common occurrence of "ghosting." This is a phenomenon in which the sooty film adheres most easily to colder surfaces, like where structural woodwork stands behind the wall surface.

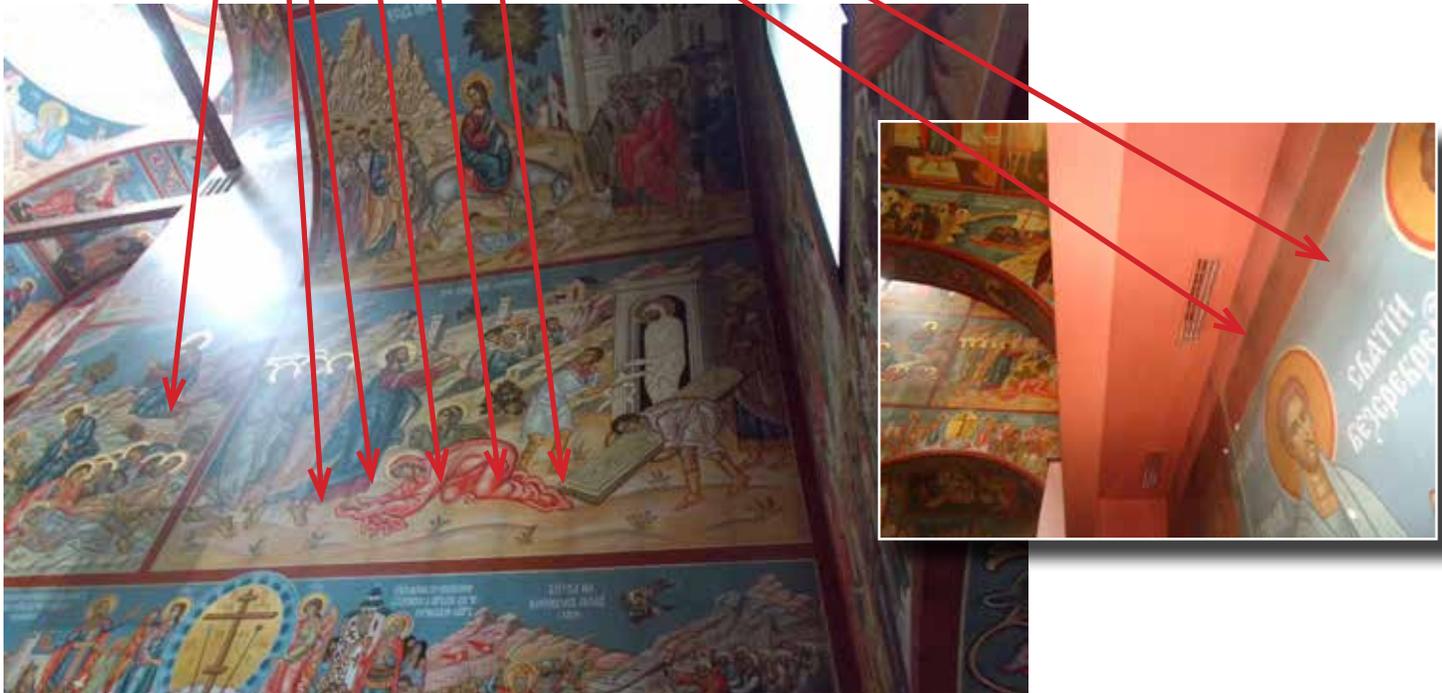
Ghosting is seen clearly:

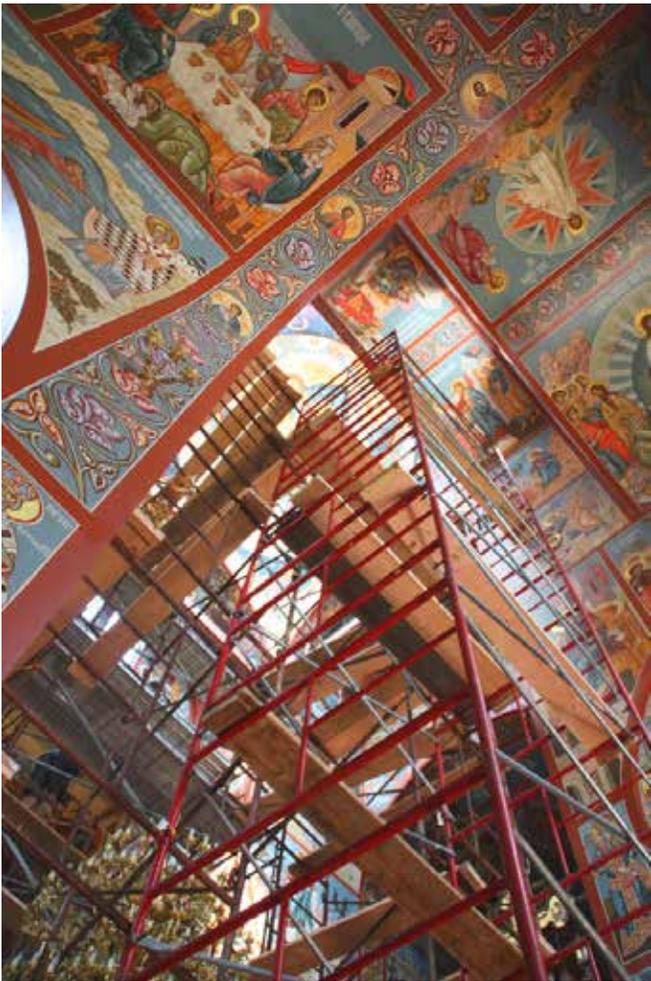
A scaffold was constructed to reach the highest point, the central dome, approximately 7 stories up. Additionally, several scissor lifts were brought in after thoroughly protecting both the entrance and the supporting floor.

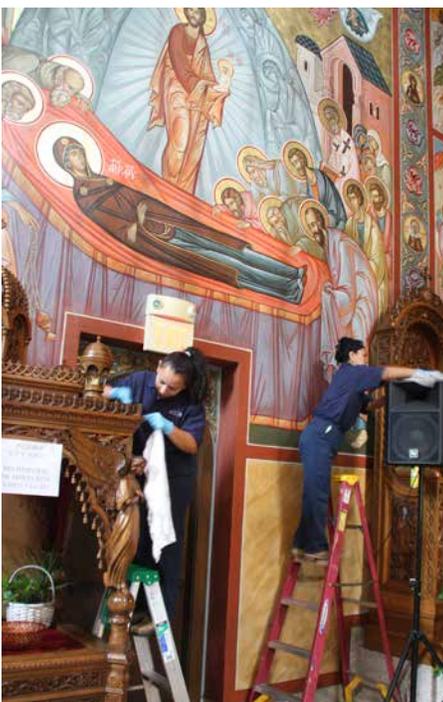
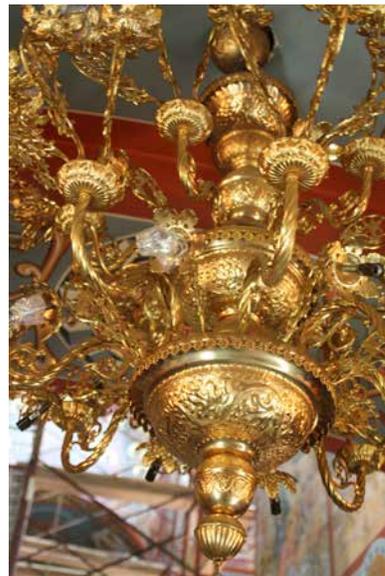
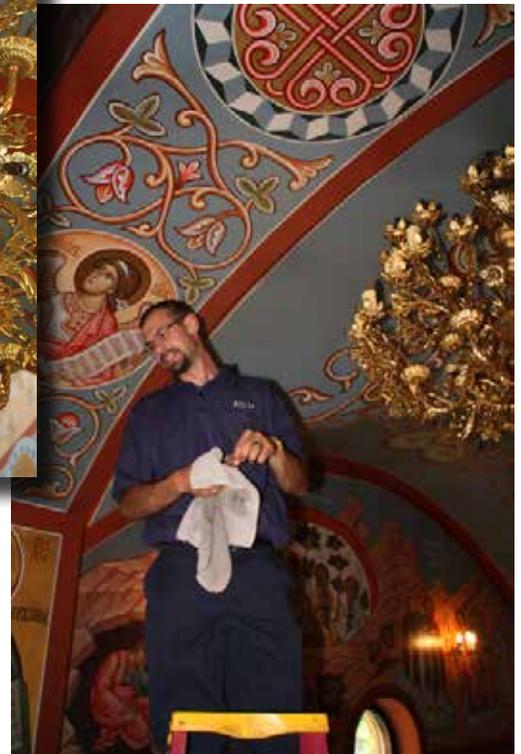
Top protocol restorative cleaning dictates that **DRY** removal of the accumulated soot was required. Wet cleaning cannot be used in situations like this, resulting in both poor results and a high potential for causing further damage.

Because of the delicate nature of the painted surfaces and highly ornamental carvings, a great deal of hand work was required by our experienced technicians.

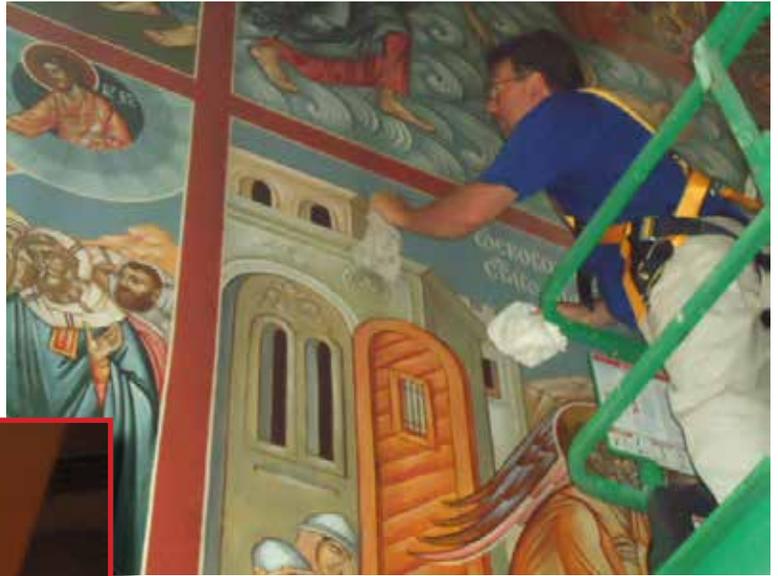
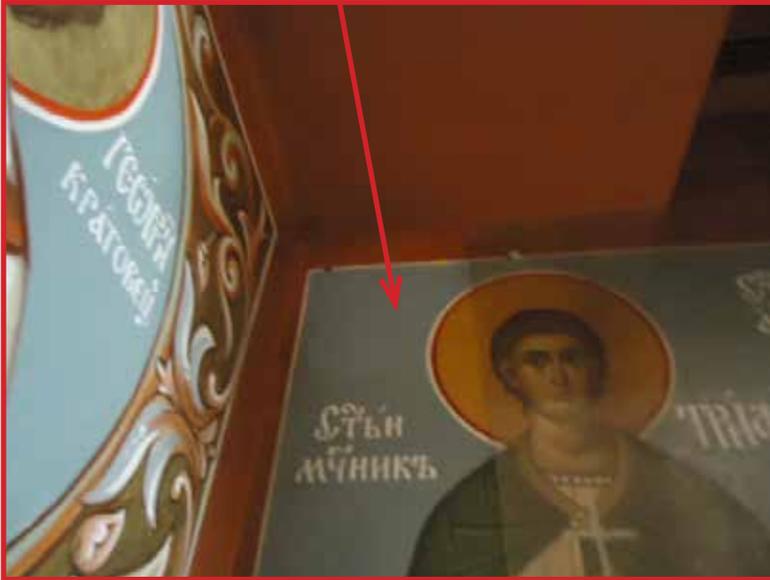
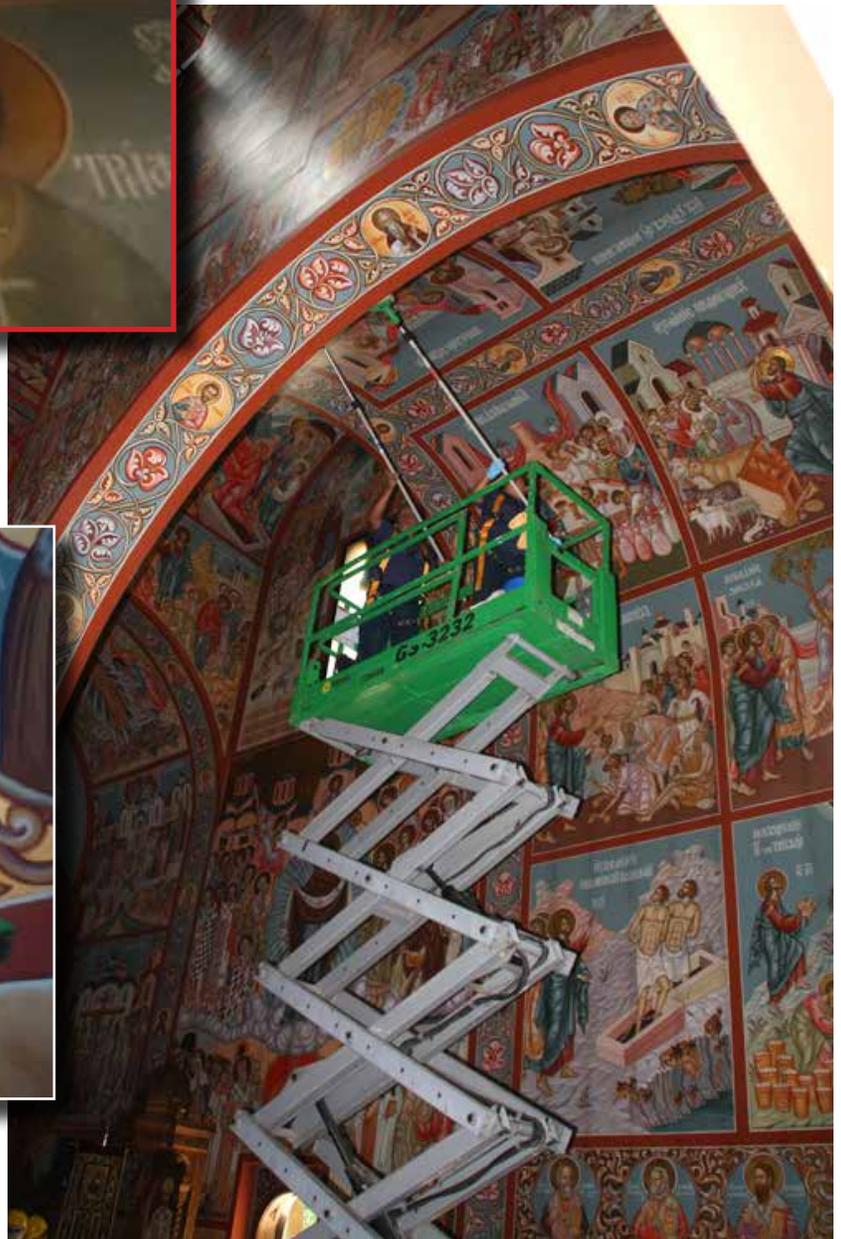
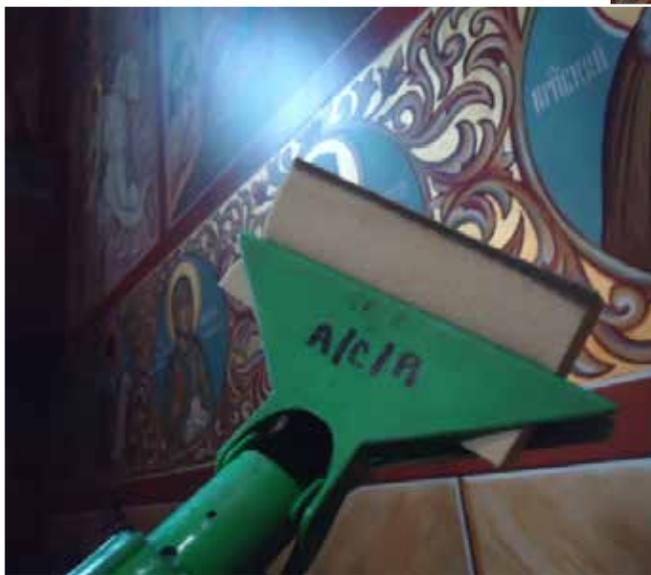
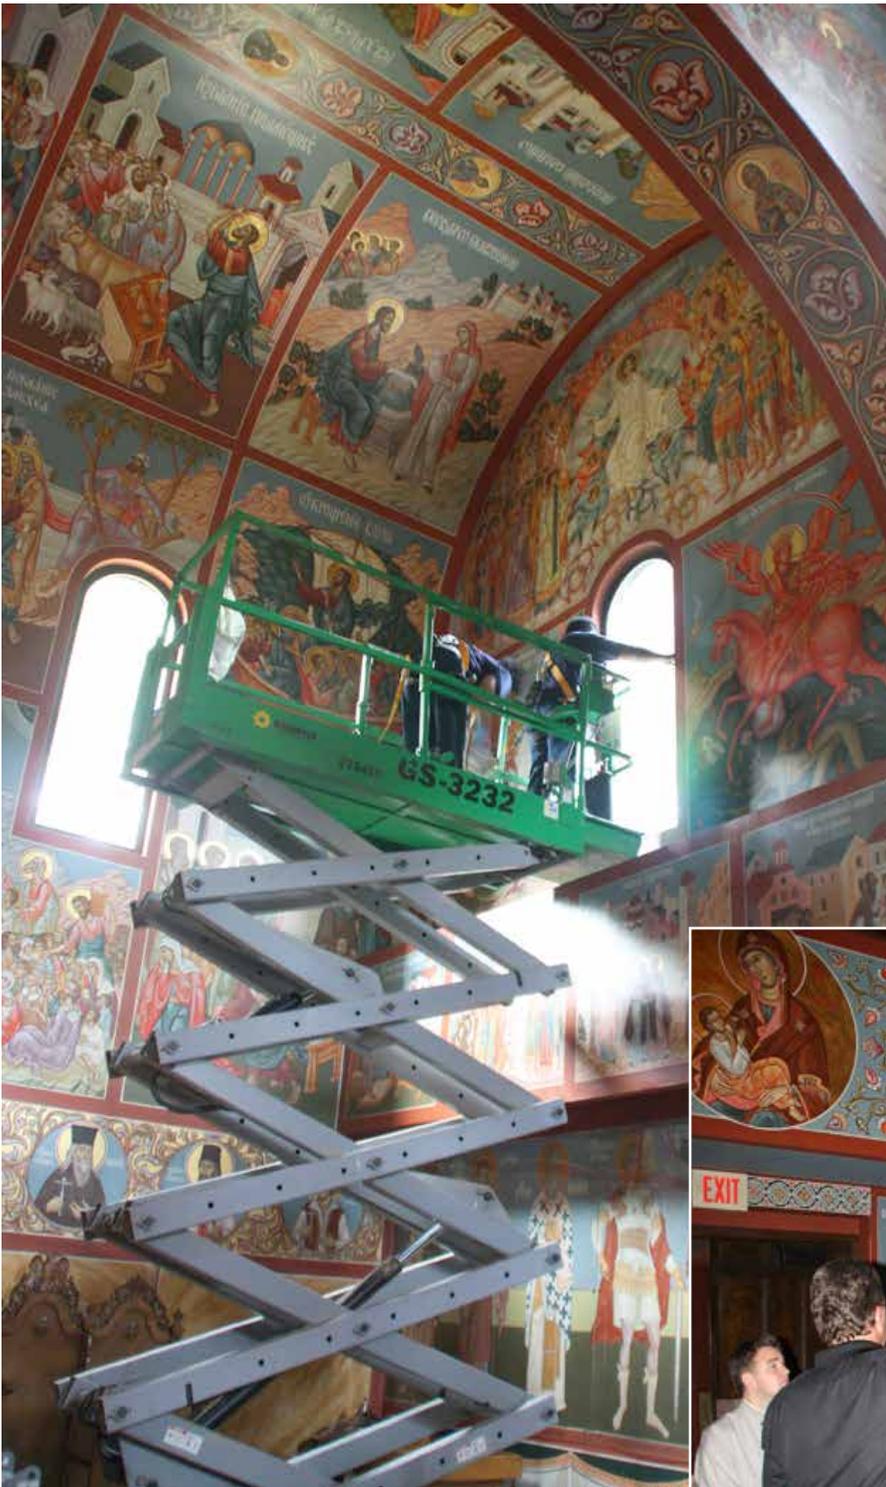
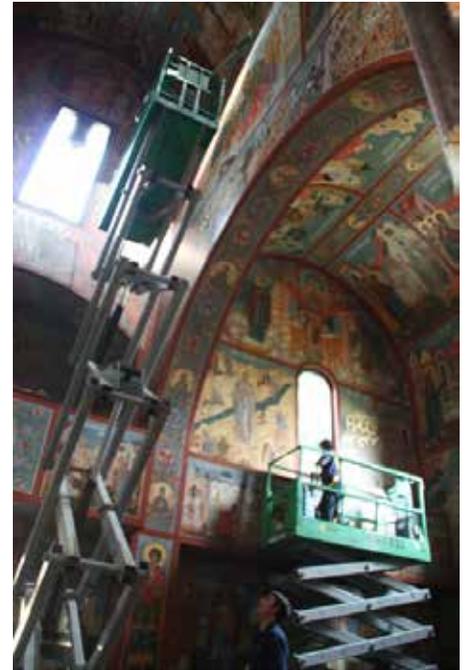
The impressive results of our dry approach are seen below. The surface is clearly restored to its original brightness and luster with the removal of the sooty film coating the surfaces with minimal risk.

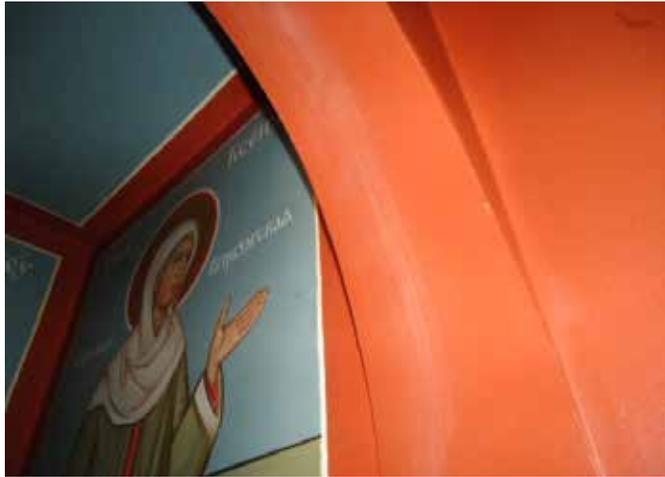
The challenges which always accompany fire/smoke damage cleaning, this project posed the additional challenge of damage caused by past improper cleaning by "wet" means. Running, streaking and physical damage was seen in numerous areas on our initial inspections.

Fortunately, by applying the correct cleaning method now, ACR was able to restore nearly all of the damage caused by "wet" cleaning in the past.

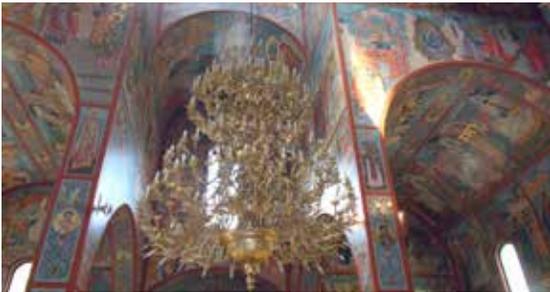
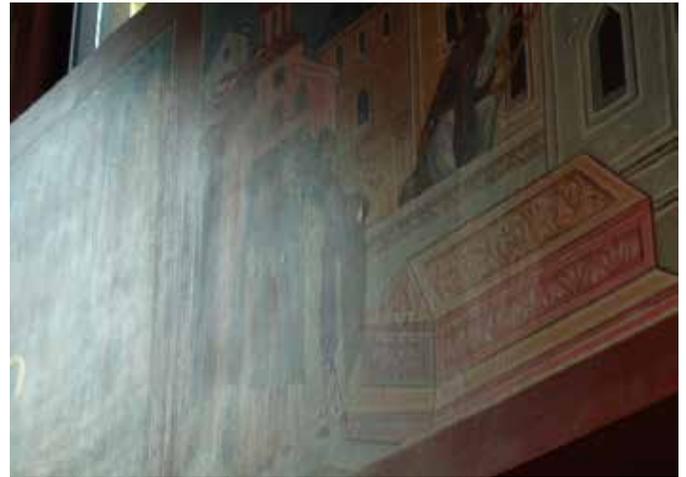
Alarmingly, in executing the cleaning of the church's enormous central chandelier, ACR ordered an electrician's assessment, resulting in the report that the chandelier was in fact highly overloaded and could at any time have caused a serious fire in itself.
