Health Care Facility: **Maintaining Operational Continuity**

In early 2013, ACR was dispatched to inspect a fire/smoke damage loss (compounded by water damage due to firefighting efforts) at a health care facility in Cook County, IL. The facility is a Medicare/Medicaid residential community and had suffered a fire associated with its laundry room as a result of work being done on the roof. There was certainly significant damage as a result of the fire and smoke, but during the process of fire damage inspection, the damage revealed a significant mold problem that otherwise had not been brought to light.

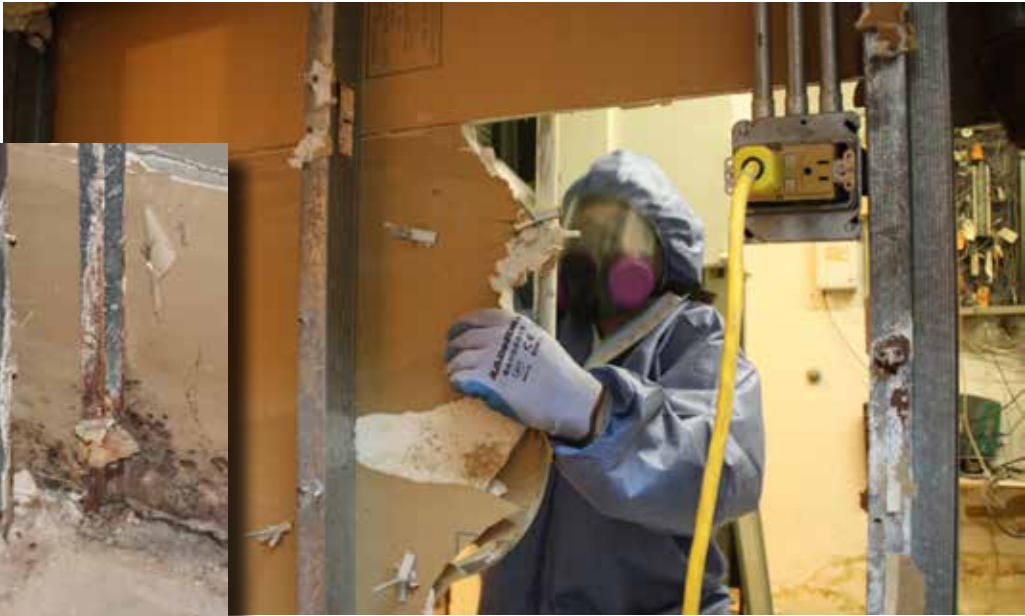
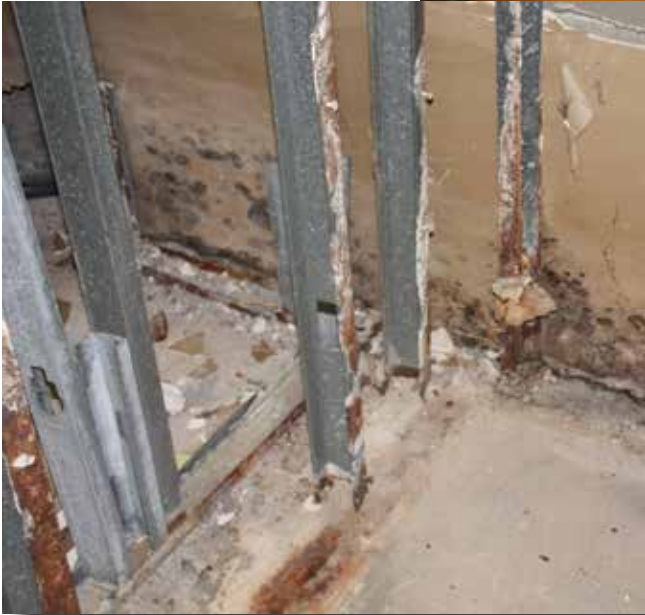
The cuts and removal proceeded throughout the affected area, behind the custom containment with minimal noise and disturbance to the facility's operation.

Proper procedure indicates the cutting of wall material a minimum of two feet above the common height of the mold growth, then the complete removal of the board below.

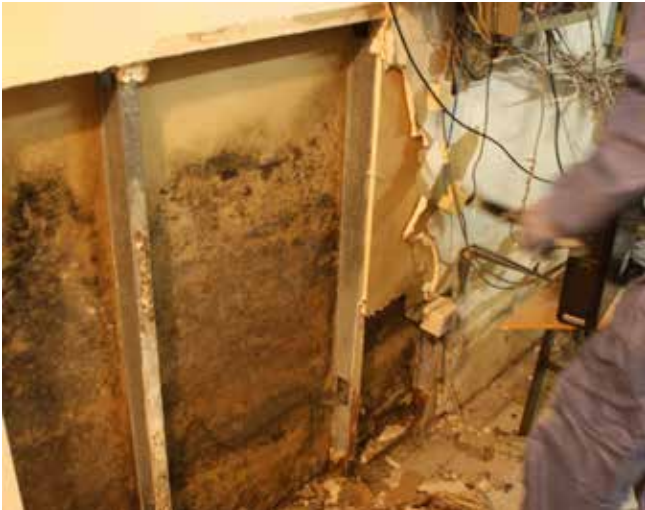
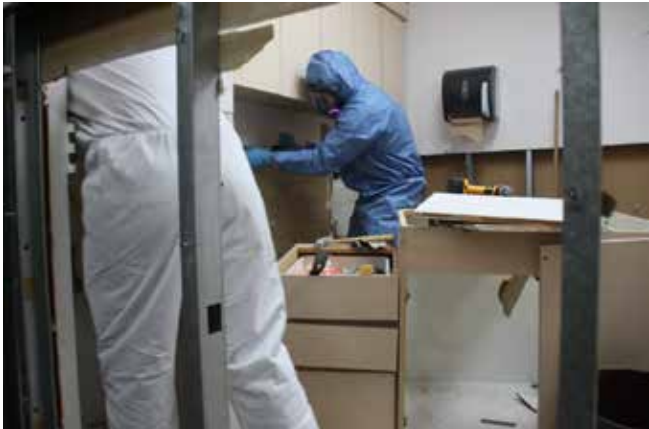
The work is carried out by ACR's certified technicians and supervised by our experienced project managers for consistently top quality results. There is no room for error when adhering to S-520 standards.

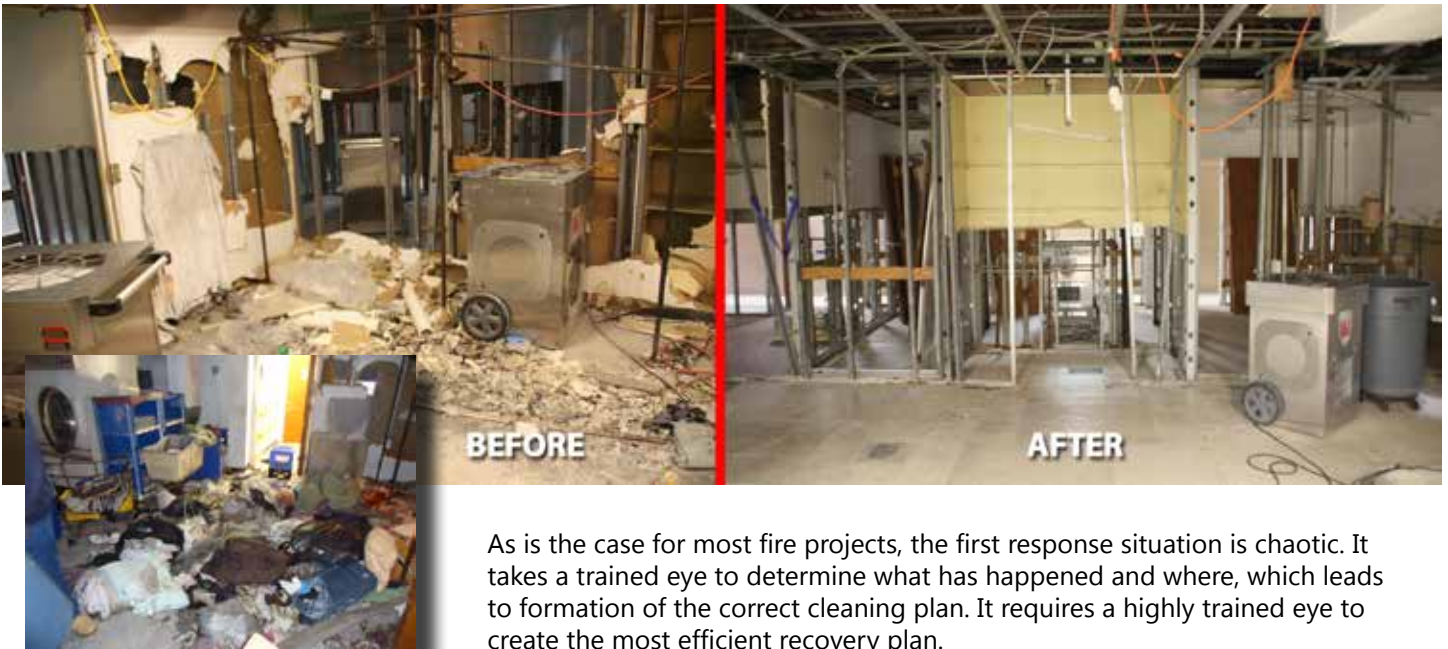
This project passed I.H. testing on the first attempt, which while common for ACR, is quite rare in the remediation industry overall. The reason is simple: ACR's experience, education and certifications, strictly following the IICRC S-520 standards, and a relentless pursuit of "spotless."

At this time, ACR's portion of the project concludes, followed by the facility's choice of contractor doing "put-back" of wallboard and flooring, the privacy containment is removed and the facility is back to normal operations.

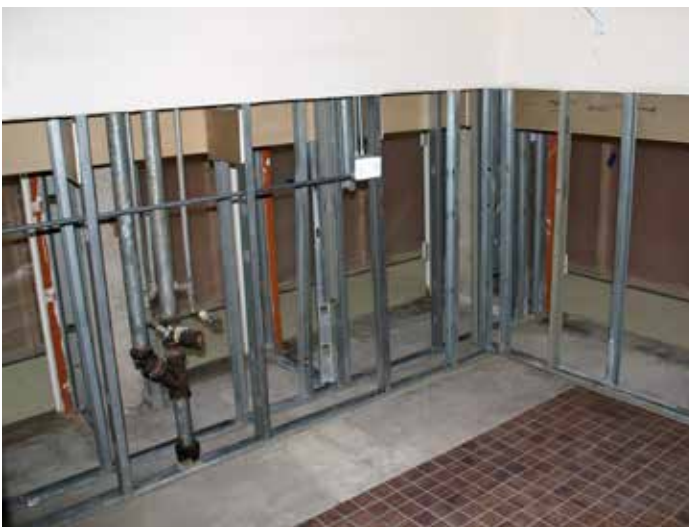
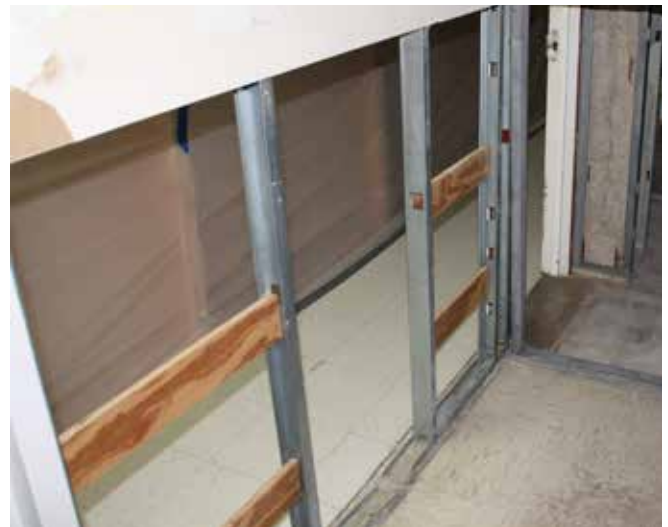
ACR brings the high level of experience and attention to detail that renders the chaos manageable and top results are achieved. The level of "clean" is startling, especially knowing that this "clean" applies on the microscopic level, as confirmed by independent third-party testing by the industrial hygienist.
